CASE REPORT

A new cone beam computerized tomography system for use in endodontic surgery

T. Tsurumachi¹ & K. Honda²

¹Department of Endodontics, Division of Advanced Dental Treatment; and ²Department of Radiology, Division of Advanced Dental Treatment, Nihon University School of Dentistry, Tokyo, Japan

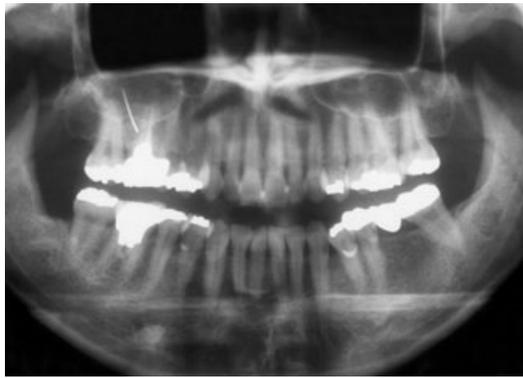
Figure 3 Preoperative panoramic radiograph showing a fractured instrument in the maxillary sinus.

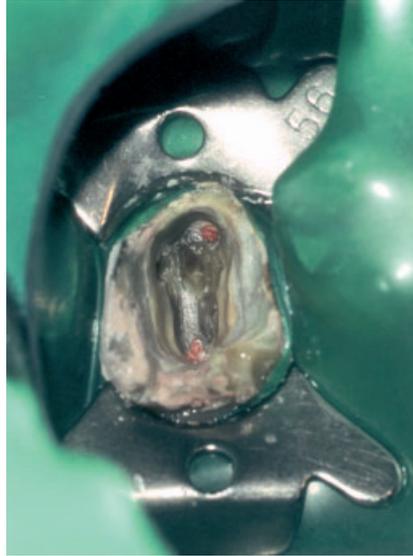
Figure 5 Photograph revealing root canal orifices and perforated site.

After removing the metal crown, inspection of the pulp chamber floor revealed three root canal orifices and an iatrogenic perforation (Fig. 5). The fractured instrument was located inside the perforation. Initially, the orthograde removal of the instrument from the perforated site was attempted, but failed. The patient was scheduled for surgical removal of the fractured instrument. It was decided that the first molar would receive a hemisection because the fractured instrument was estimated to be too difficult to reach and locate.
