Roots Summit 3, Anaheim

Vertical crack in tooth # 11 (23 FDI) , no pain, but patient has had a funny feeling for several years in the middle of the root just below the attachend gingiva.

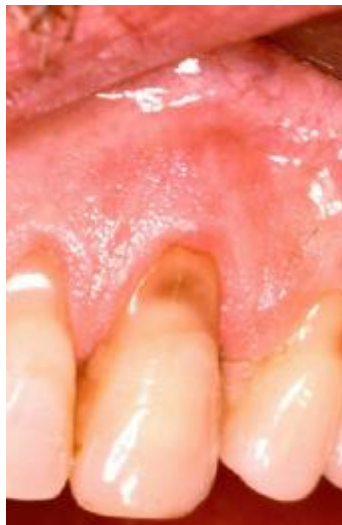
Probing with normal pressure is rather unspectacular

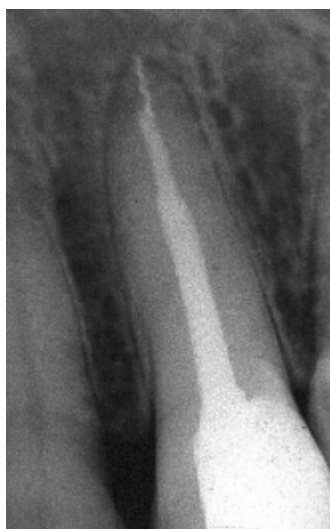
X-ray shows a root canal filling with a fractured lentulo spiral at the tip

I intended to do an apico and an adhesive repair of the crack

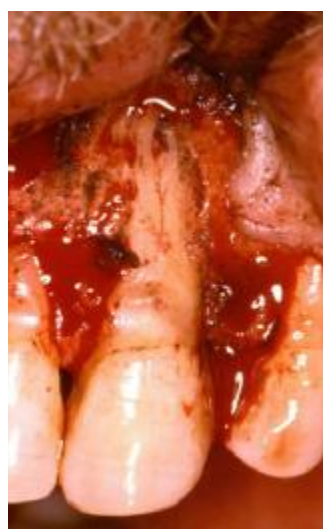
There was a crack all the way down the root and a resorption area in the middle of the root, where the patient had had the funny feeling

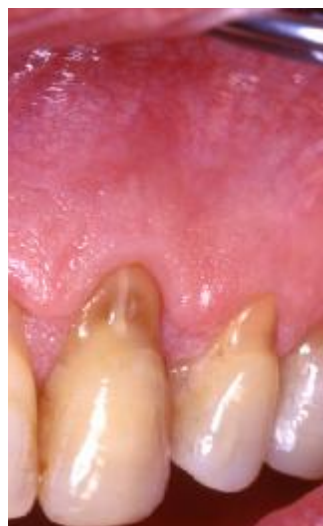
5 months later, it looks fine and the patient feels fine too

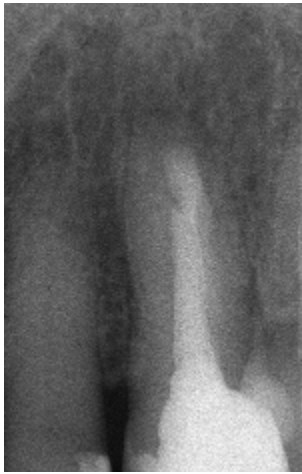
Five months later, the lesion has almost completely healed

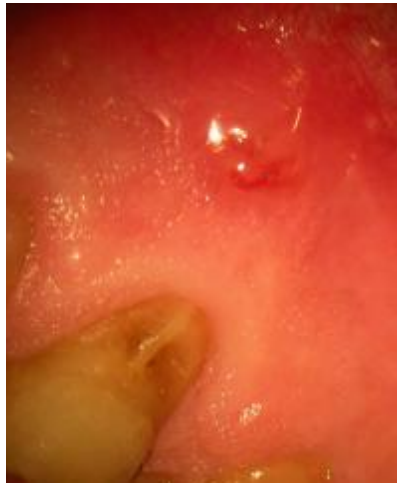
Nine months later: tooth is mobile, sinus tract in the middle of the root

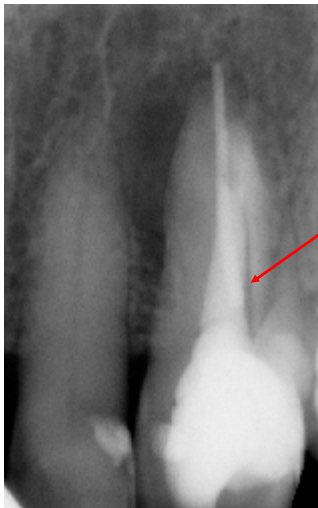
X-ray shows large lateral translucency

Translucency in the root indicates a crack

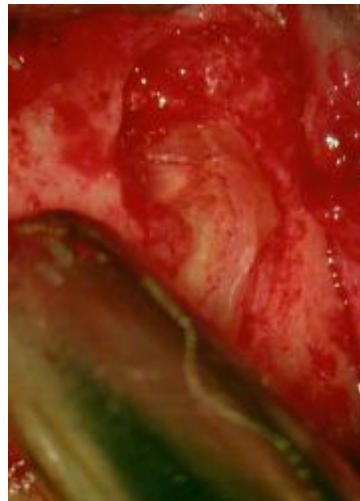
I reentered the case to see what was going on

Picture shows the repaired root

and a new fracture line on the mesial aspect of the repaired area going all the way over to the palatal side: the root was split right in half.

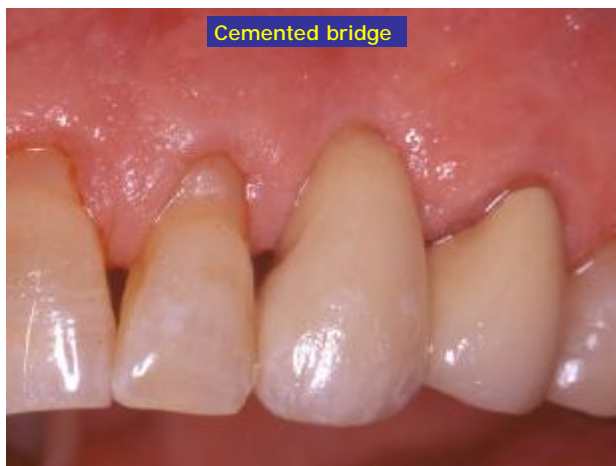
Cemented bridge

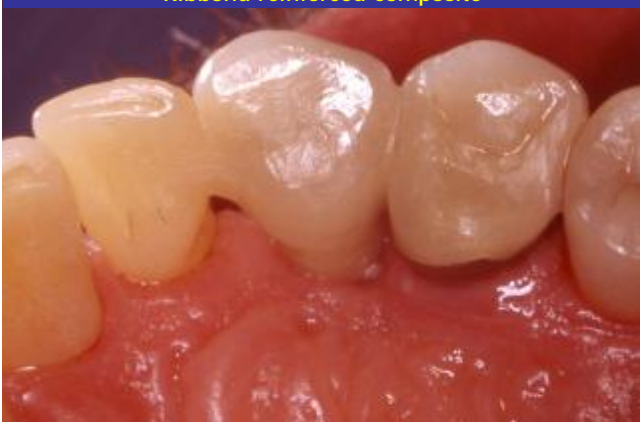
Palatal view of the bridge connected to the lateral with Ribbon reinforced composite
