Bypassing a fractured instrument

Author_ Dr Rafaël Michiels, Belgium

_Case report

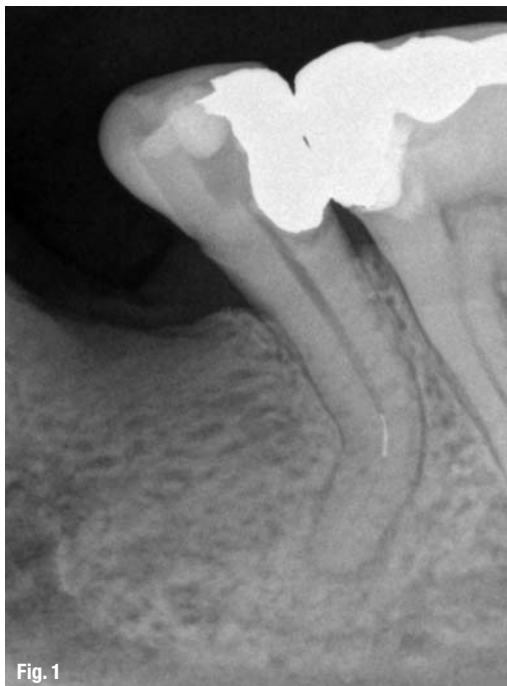
Fig. 1 _Diagnostic radiograph showing a separated instrument in the canal at the curvature.

Before starting the treatment, a new diagnostic radiograph was taken (Fig. 1). It showed a fractured instrument in the curvature of the root. The tooth was isolated with a rubber dam and the coronal filling was removed. Straight-line access was established, as this is imperative to be able to reach and see the fractured instrument. In this case, the fractured instrument could not be visualised (Fig. 2). The decision was made to try to bypass the instrument rather than try to retrieve it. The key factors for this decision were the impossibility of visualising the instrument, the location of the instrument, the

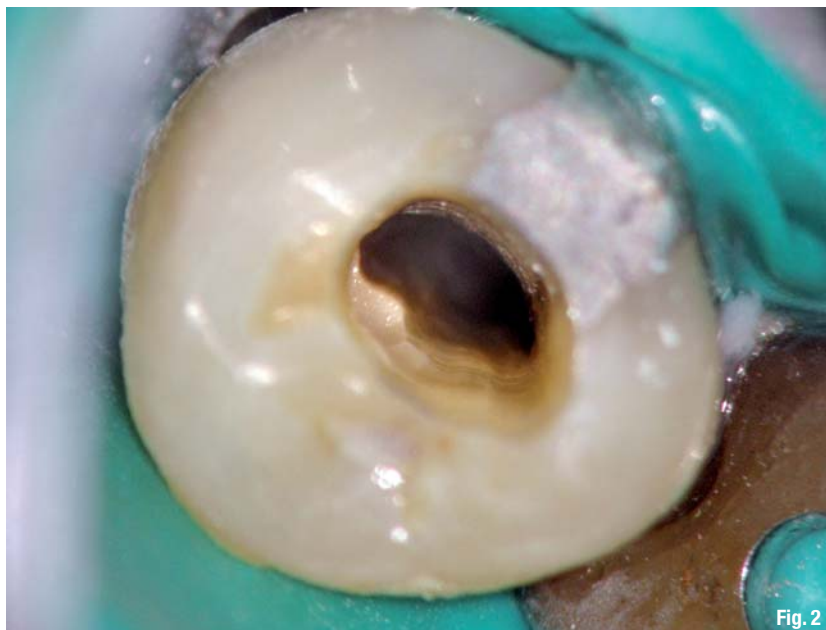
Fig. 2 The instrument was not visible through the microscope.

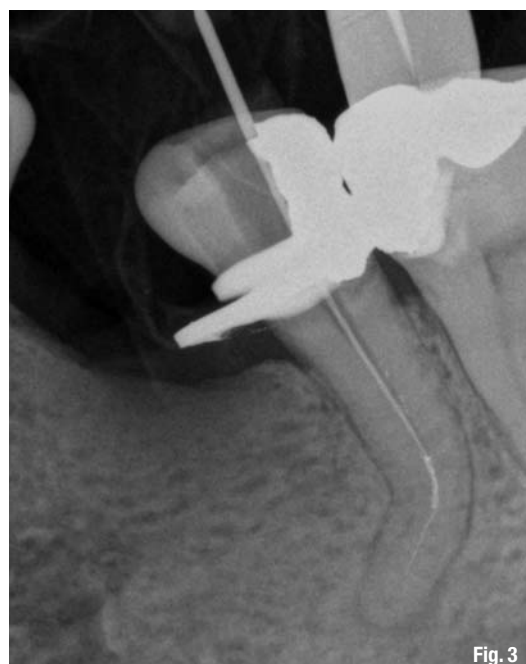
Fig. 3 Bypassing of the instrument with a size 08 D-Finder.

limited thickness of the root and the canal's oval shape. Bypassing was started by introducing a size 08 D-Finder (Mani Inc.) to the instrument. The D-Finder was used for probing and searching for a way to bypass the instrument. After a few tries, I was able to get the D-Finder past the instrument (Fig. 3). Working length was established using the Root ZX mini (J. Morita) and confirmed radiographically (Fig. 4). The complete shaping sequence of the first appointment is shown in Table I.

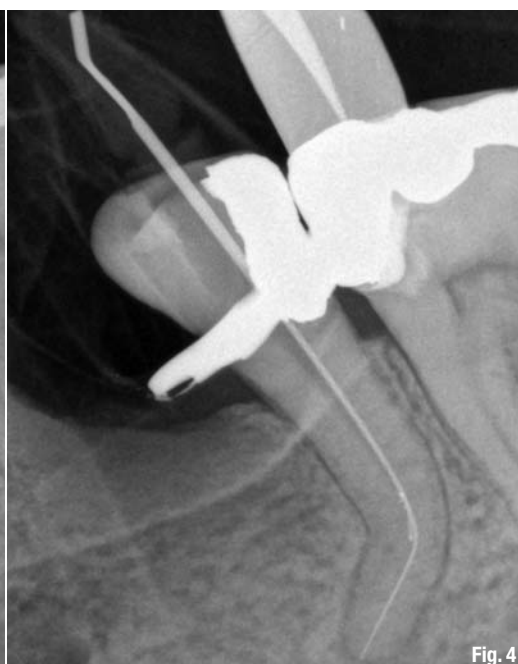
Fig. 4 Working length determination.

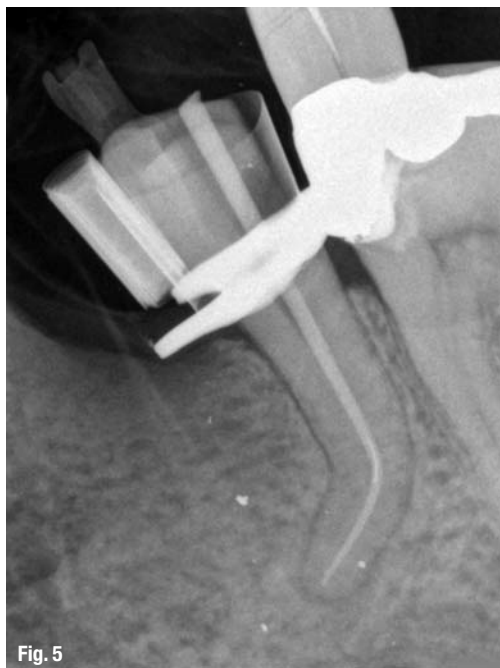
Fig. 5

Fig. 5_ Gutta-percha cone-fitting.

Topseal (DENTSPLY Maillefer) was used as a root-canal sealer. After radiographical confirmation (Fig. 5), additional gutta-percha cones, ISO size 20, were placed into the canal, according to the cold lateral condensation technique. Next, the gutta-percha was removed to about 5 mm from the apex with the System B Elements Obturation Unit (SybronEndo). Owing to the curvature, it was not possible to go any deeper. Hence, I decided to create

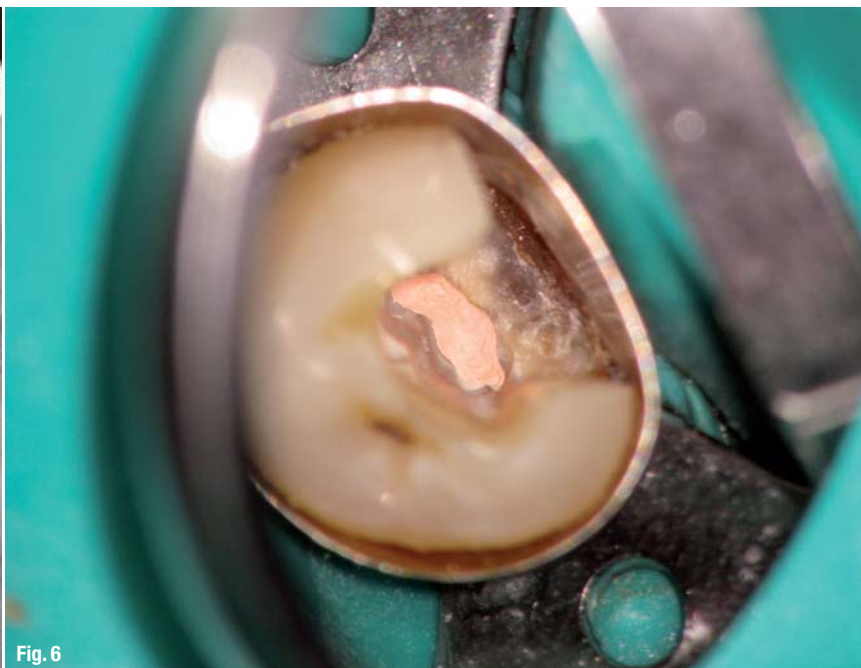
Fig. 6

Fig. 6_ The pulp chamber after obturation with gutta-percha.

a hybrid technique with cold lateral condensation. Finally, the backfill was done with the Elements Obturation Unit. After obturation (Fig. 6), a temporary restoration in glass-ionomer cement (Fuji IX FAST A1, GC) was placed. Final radiographs were taken, both parallel and angled (Figs. 7 & 8). The prognosis of this case was excellent and the patient was referred to his general dentist for a definitive coronal restoration.

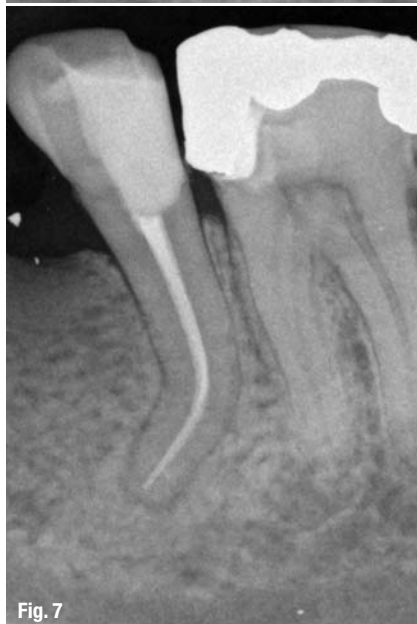
Fig. 7

Fig. 7_ Final radiograph (parallel).

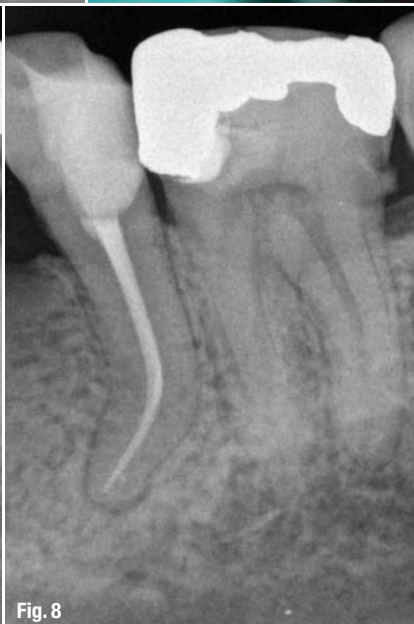
Fig. 8

Fig. 8_ Final radiograph (angled).
