Thermal injury through intraradicular heat transfer using ultrasonic devices: Precautions and practical preventive strategies

J Am Dent Assoc 2005;136;1286-1293

Thermal injury through intraradicular heat transfer using ultrasonic devices

Precautions and practical preventive strategies

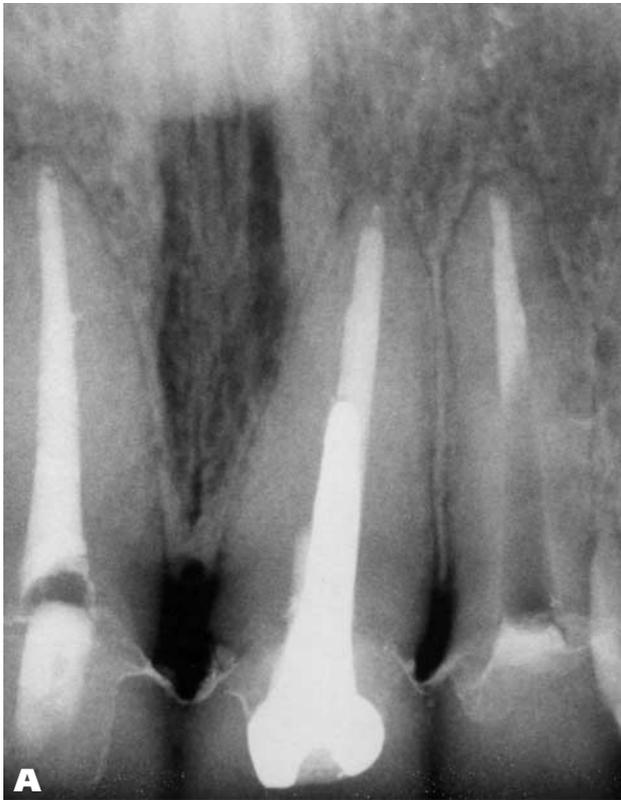
Figure 1. A. Preoperative radiograph of a metal post in tooth no. 9. B. Postoperative photograph showing burn injuries to tooth no. 9 and its supporting structures that occurred during heat transfer. C. Tooth no. 9 was extracted 48 hours after injury took place. D. Extracted tooth no. 9 shows an absence of viable attachment to the apical one-third of the root.

Case 1. A 50-year-old woman with no significant medical history was scheduled to have a metallic post removed from tooth no. 9 and to have it replaced with a composite glass-fiber post for the esthetic reason of gray "show-through" at the cervical area of the crown. In addition, teeth nos. 8 and 10 were to receive esthetic posts in preparation for crowns. The patient wore a rubber dam during treatment and experienced some pain during the course of post removal, even while anesthetized. The removal process lasted about an hour.

Tooth no. 9 was extracted after 48 hours owing to burn injuries to the teeth and their supporting structures that occurred during heat transfer. The patient underwent several attempts to repair the alveolar ridge by distraction osteogenesis (Figure 1).

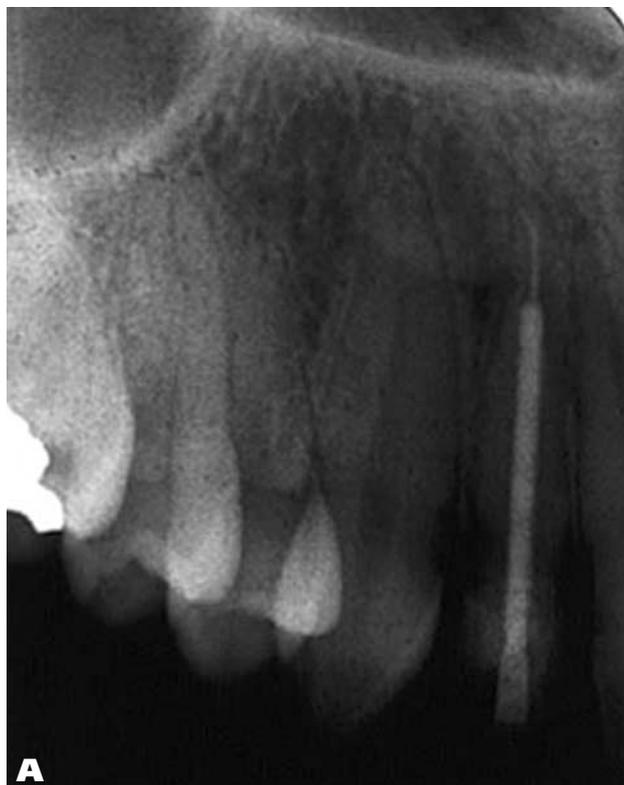
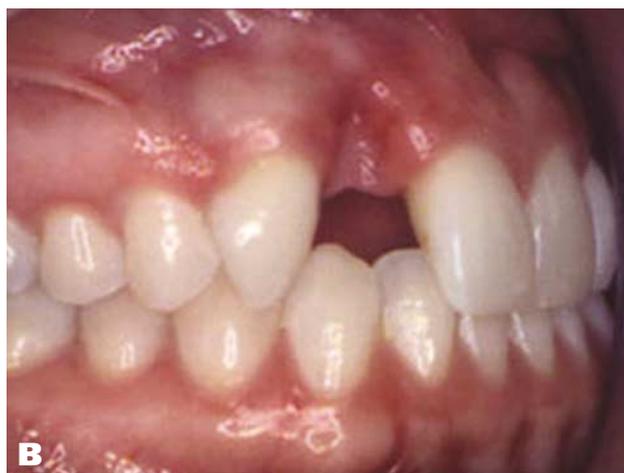
Figure 2. A. Preoperative radiograph of the post in tooth no. 7. B. Postoperative photograph showing healing of burn injury with resultant bony defect.

Case 2. The patient was a 35-year-old woman with a noncontributory medical history. The clinician was removing the post from tooth no. 7 because of a crown fracture that required a rehabilitation of the post-core complex and a re-treatment of the pre-existing endodontic therapy. The dentin structure of the lateral incisor was thin, and the post was long, extending to the apical one-third. The burn occurred during ultrasonic removal of the post. The loss of the tooth and bone in this case created a difficult esthetic problem for the patient (Figure 2, page 1290).

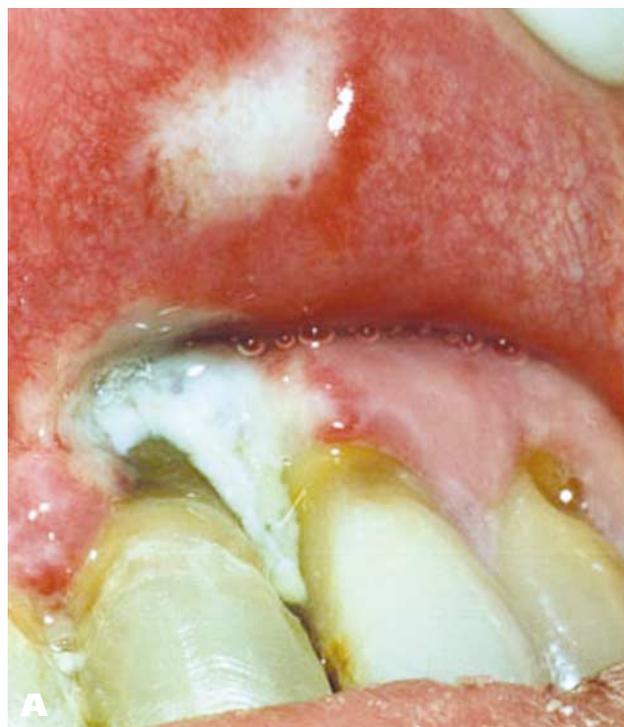
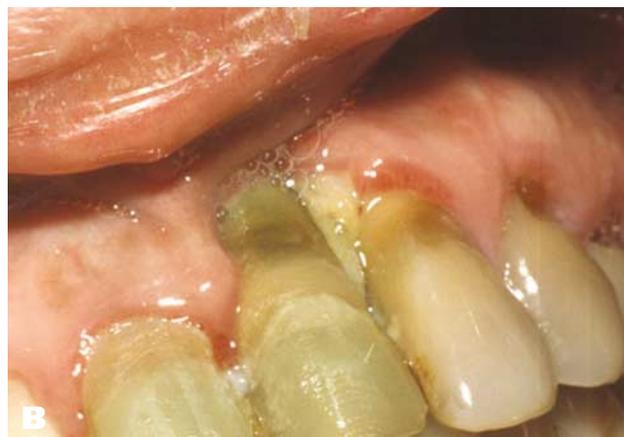
Figure 3. A. Postoperative burn on the gingiva and lip after the posts were removed. B. Photograph 48 hours after the burn injury occurred.

Case 3. The patient was a healthy 30-year-old woman. The clinician was replacing the posts in teeth nos. 8 and 9 for restorative reasons. The posts were negligently overheated during the attempted removal, which caused severe destruction of tissue and bone, as well as the loss of both teeth (Figure 3). Augmentation procedures were required to repair the alveolar ridge.

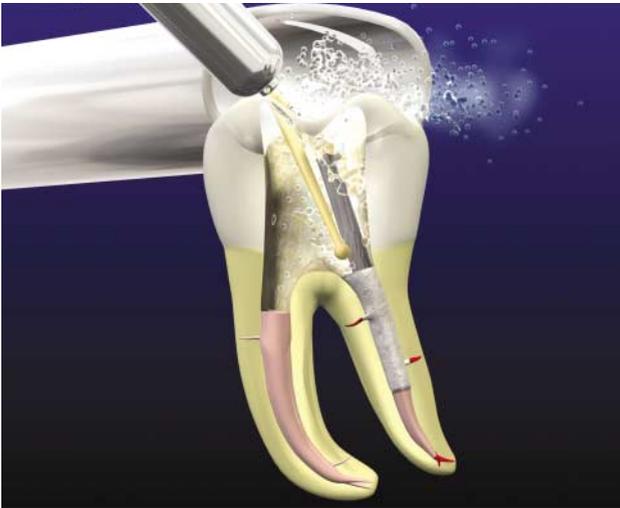
Figure 4. An ultrasonic device instrument used with copious irrigation.

potentially dislodge, the post. The selected ultrasonic device is energized at the lowest power setting that will perform the clinical task safely and is moved up, down and around the exposed length of the post. When ultrasonic procedures are performed, especially at higher energy levels for longer periods and against larger and more conductive posts, heat is generated.⁶ As such, the field should be flushed with water frequently to decrease heat buildup and the potential for dangerous heat transfer to the attachment apparatus³ (Figure 4). Fortunately, when a water coolant is used frequently and voluminously, the danger for heat transfer is minimized, and the heat is further dissipated owing to the moisture content in the attachment apparatus.^{5,6,37} In general, after removing all restorative materials from the pulp chamber, most posts can be removed safely within approximately 10 minutes.^{25,38}
