Rips, Strips and Broken Tips: Handling the Endodontic Mishap

PART I: THE SEPARATED INSTRUMENT

Steven J. Cohen D.D.S., Cert. Endo.; Gary D. Glassman, DDS, FRCD(C);
and Richard Mounce, DDS

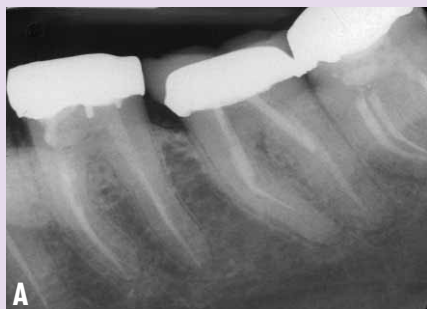
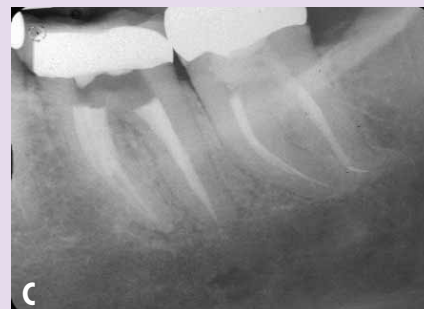
FIGURES 1A, B & C—DANGEROUS CURVES **A)** Failure to recognize that the mesio-lingual canal has a slight buccal curvature in addition to the obvious distal curve, resulted in file separation in tooth #37. Note the separated files in tooth #38 as well. **B)** Refined access design, and ultrasonics loosened the file for removal. **C)** Obturation of the canal system with sealer and thermoplastic injection of gutta percha.

Rotation through a curve is great, but rotation through more than one curve in the same canal can be lethal, in terms of the life of the instrument (Figs. 1-4).

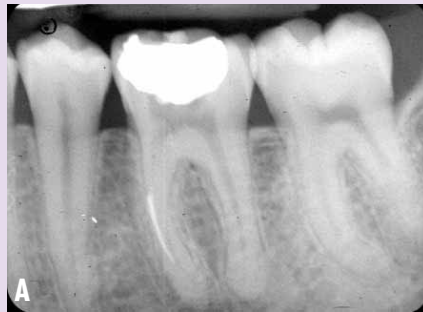
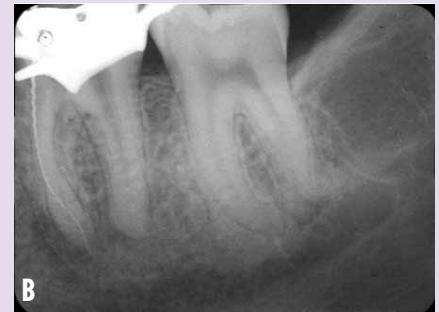
FIGURES 2A & B—DANGEROUS CURVES **A)** Separated file midroot in tooth #36. **B)** Refined access design, the file segment liberated, and a trial file displaying the double curve in this mesial canal.

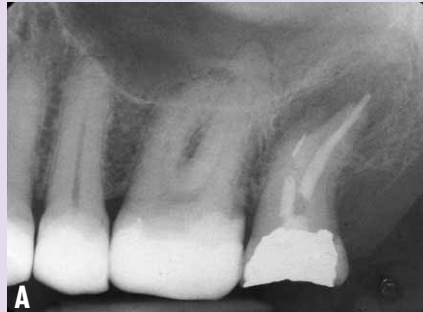
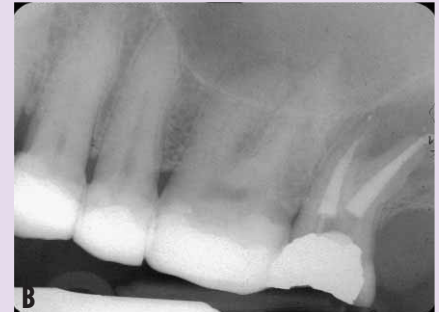
FIGURES 3A & B—DANGEROUS CURVES **A)** A two-rooted maxillary 2nd molar, tooth #27, with a separated file noted in the apical third of the buccal root. **B)** Obturation reveals the nature of the “S” curve in the apical third of this root.

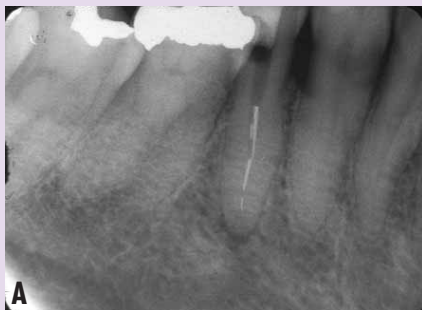
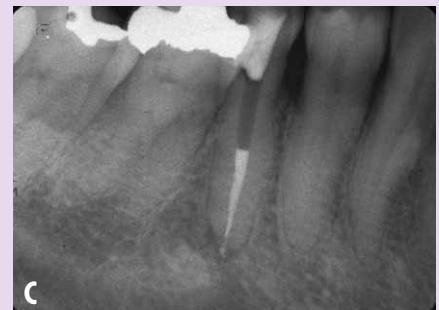
FIGURES 4A, B & C—DANGEROUS CURVES **A)** Four pieces of broken instrument noted in this mandibular bicuspid, tooth #45. **B)** Removal of three pieces, with the stubborn fourth piece stuck at the the apical third where the canal curves to the lingual. Trial file bypassed the last fragment. **C)** Bypass and sealing the fragment into place, around the apical curve.

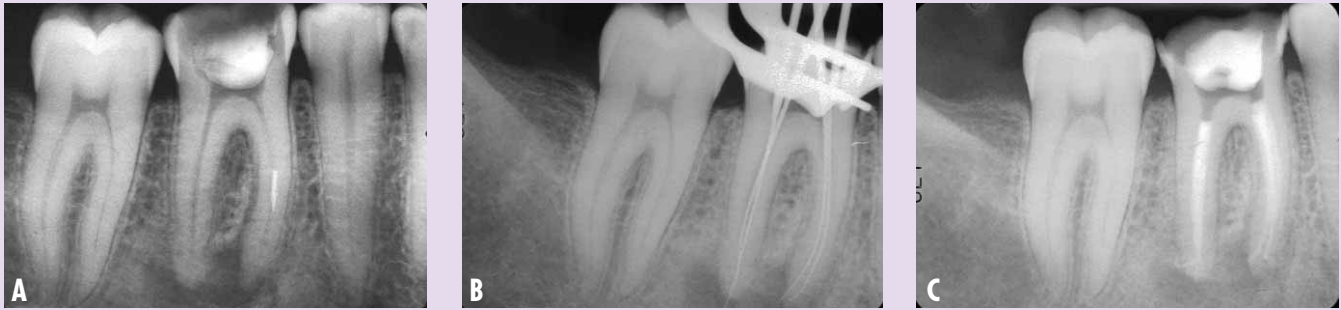
FIGURES 5A, B & C—THE “RUNAWAY GATES-GLIDDEN” BUR **A)** Improper access design has left a large triangle of dentin narrowing the entrance to the mesial canals. The Gates-Glidden was stressed to the point where the head separated in the middle third of the canal. **B)** Because of the flute design on the bur head, a #10 Hedstrom file could negotiate by the blockage. Sequentially larger files, and minimal ultrasonics would loosen and dislodge the file head. Lengths verified by film. **C)** The cleared canal paths are cleaned, shaped and obturated with sealer and thermoplastic injection of gutta percha.

The “runaway Gates-Glidden” is an example of the instrument being asked to do more than its design could handle (Fig. 5). There was an overhanging dentinal ledge at the chamber roof level, another triangle of dentin at the mesial canal orifice, and no true glide path was established. Although rare, this Gates-Glidden bur separated at the head, and not at the shaft as per usual. This is a factor of the stress put on that instrument in that canal. A rush to use rotary instruments without establishing a proper

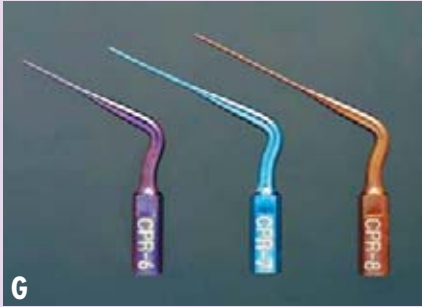
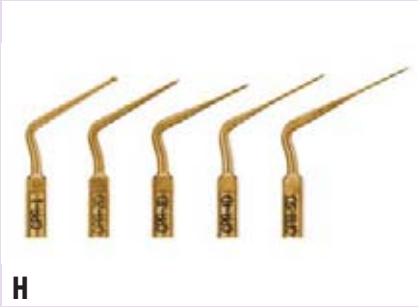
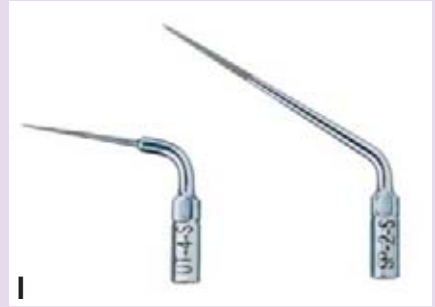
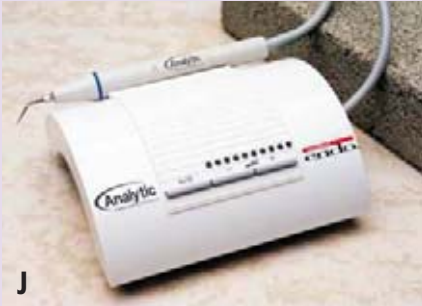
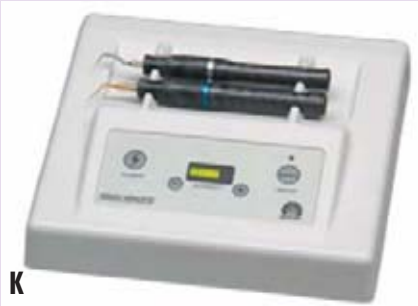
FIGURES 6G-K—ISOLATION, TOUGHTING AND RETRIEVAL **G)** CPR™ titanium tips (Obtura Spartan, Fenton, MO). **H)** CPR™ diamond coated tips (Obtura Spartan, Fenton, MO). **I)** UT-4-S™ and the SP-2-S™ (SybronEndo, Orange, CA). **J)** Mini Endo Ultrasonic Unit (SybronEndo, Orange, CA). **K)** Spartan-MTS Unit (Fenton, MO).

available to use at this stage. A long, thin CPR™ #8 titanium tip (Obtura Spartan, Fenton, MO) (Fig. 6G) can be used at lowest power, with the tip applied to cir-

This is continued until some length of the file is standing free within the canal space, and some movement of the fragment is noted. Once some movement is seen, a second diamond coated zirconium tip, such as the CPR-5D (Obtura Spartan, Fenton, Missouri) (Fig. 6H), the UT-4-S™ or the SP-2-S™ (SybronEndo, Orange, CA) (Fig. 6I), can be applied with the tip activated once in contact with the metal fragment only.

the Mini Endo Unit (SybronEndo, Orange, CA) (Fig 6J) or the Spartan-MTS Unit (Fenton, Missouri) (Fig. 6K) can be most efficient for this, where the two different tips are loaded and ready to go. Also, one unit can be programmed to run with water, while the adjacent ultrasonic handpiece can run dry. The intermittent water and air coolant from the Stropko™ (SybronEndo, Orange, CA) device on the air/water syringe, and two different metal surfaces activated on the fragment, in many cases, can loosen and even dislodge the metal piece. Unfortunately, this process is very tedious and can often take one whole working appointment (60 to 90 minutes). The ultrasonic tips often wear out or break during this procedure. In a difficult case, this should be an expected event.

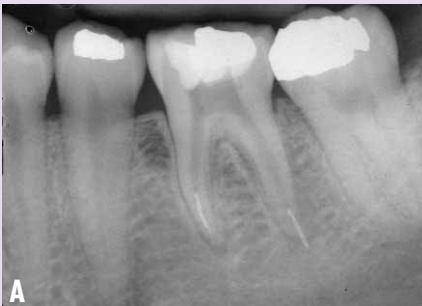
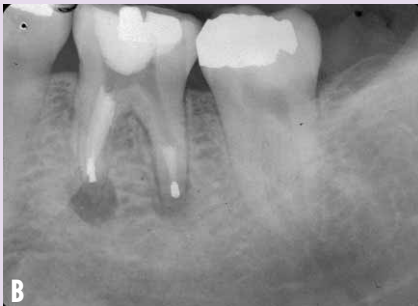
FIGURES 7A & B—SURGICAL RETRIEVAL **A)** Two separated files, apical to the curve in the mesial root, and part way through the apical constriction in the distal root. **B)** The canals were treated conventionally first, then apical surgery was performed at the same appointment to remove these fragments and seal the apices.

When dentin is removed to free up a binding point, the file straightens even further and binds again. Sometimes, the NiTi fragment is seen to be reduced flute by flute as the process continues, and may result in a non-retrievable smaller piece lodged in the canal below the level of the curve. These cases have the poorest prognosis (true blockage) and that fragment may only end up being liberated by surgery (Fig. 7).

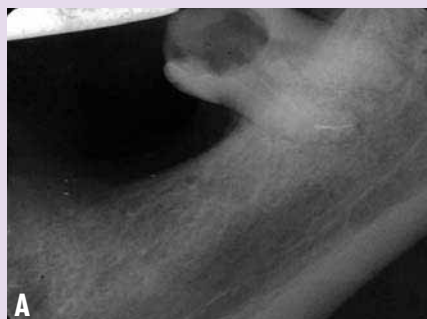
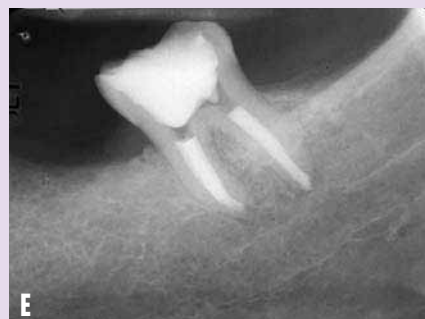
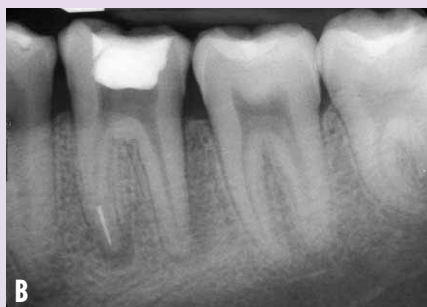
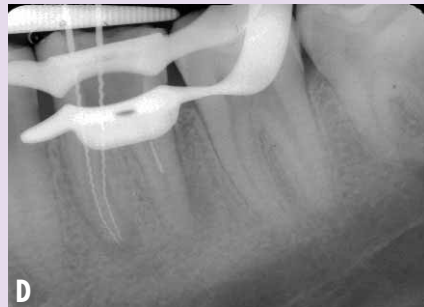
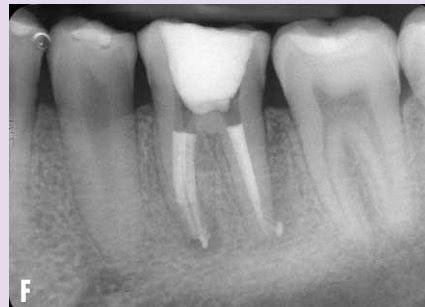
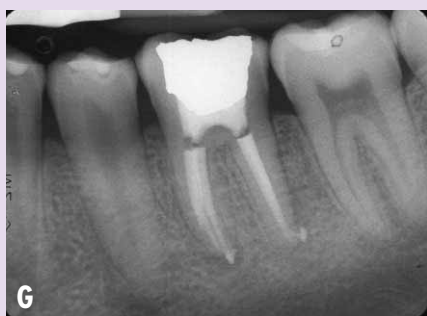
FIGURES 8A-G—THE “BOUNCE” **A & B)** Two mandibular molars, #36 and #37, with separated file fragments in the mesial roots, below the level of the curvature. **C & D)** After staging, ultrasonic energy was applied, alternating titanium and zirconium tips. The fragments “bounced” out of the mesial root, and landed in the distal canals of each tooth! **E & F)** The pieces were floated out of the distal canals (not binding there), and the cases were completed. **G)** Three month recall of the treatment on tooth #36.

With the fragment showing movement when ultrasonic energy is applied, a small (.06 or .08) carbon steel hand file (SybronEndo, Orange, CA) can be utilized to try and bypass the loose piece. The carbon steel is end-cutting, and a harder metal than either stainless or nickel-titanium. Once bypassed, you have now regained the canal space lost on the initial separation of the instrument. This should be repeated with gradually increasing diameter sizes of files. As the canal space opens around the fragment, ultrasonic energy again (diamond coated tip) will help to jar the fragment and can cause a “bounce” where it will move coronally within the canal space (Fig. 8).

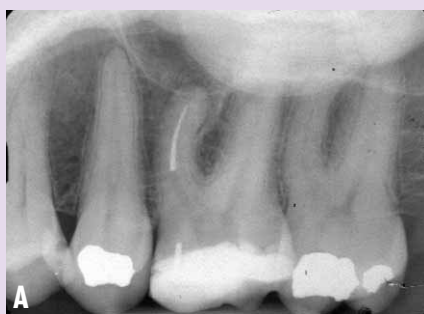
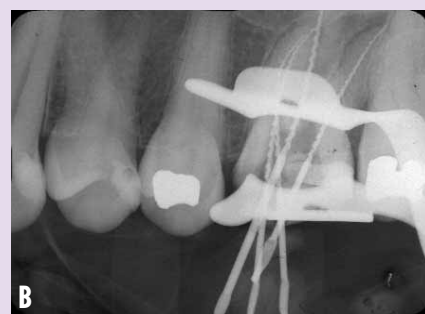
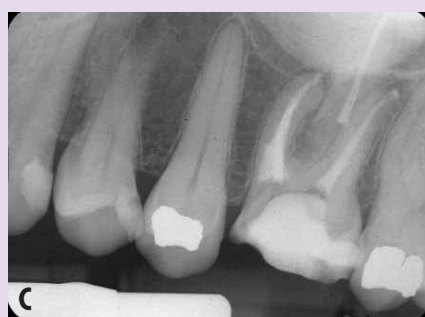
FIGURES 9A, B & C—DISTORTION OF THE ROOT WALL **A)** Large piece of instrument in the mesio-buccal root of tooth #26. **B)** Troughing around the segment, and location of a second MB canal aided in the retrieval of this piece. **C)** Excessive flaring of the MB canal necessary to retrieve the file is evident on the obturation film.

A severe curve in the root will limit the amount of dentin that can be removed along the “safe” wall (Fig. 9). Perforation through the side of the root is not uncommon, and knowledge of root anatomy and experience dictate when the clinician must stop before pushing the ultrasonic dentin

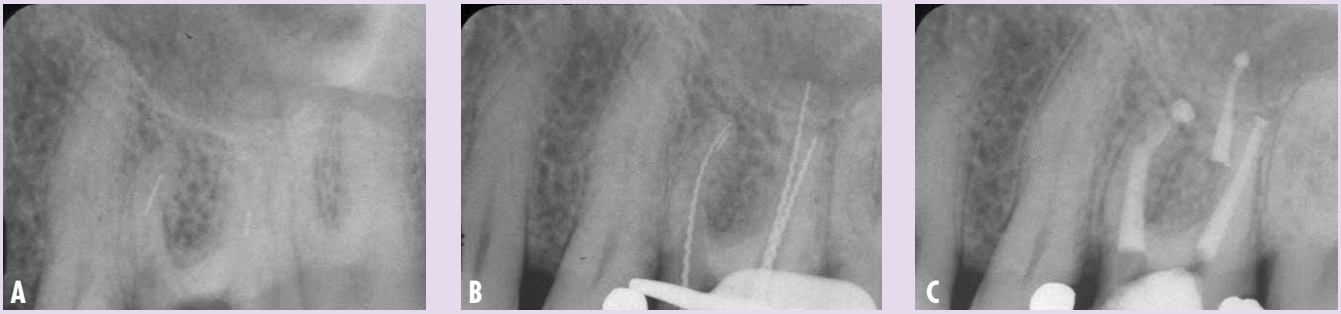
FIGURES 10A, B & C—BYPASS AND SEALING INTO PLACE **A)** Small fragment located in the apical third of the MB root of tooth #26; small fragment also noted in the midroot level of the DB root. **B)** Removal of the DB fragment. Reduction of the size of the piece in the MB canal, and bypassing to the apex. **C)** Obturation incorporating the remaining segment into the fill.

Bypass and sealing the fragment into place can be very successful, if the canal is thoroughly cleaned around the obstacle, and the apical terminus is sealed (Figs. 10 & 11). True blockage also does not mean automatic failure. If the bulk of the canal space has been soaking in full strength sodium hypochlorite, and the critical concentration of bacterial contaminants within the canal are sufficiently reduced, the body may heal around this root as well.
